John H. Overton Upstream Lock Guard Wall Prototype Experiments

by Frank M. Neilson

Final report

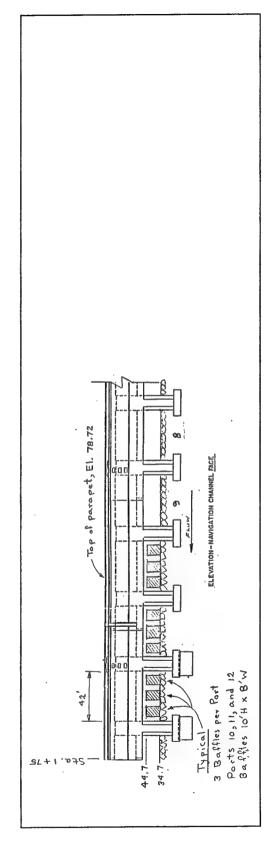
b. Final layout, Ports 10, 11, and 12 are baffled

The upstream approach, including the guard and guide walls, is shown in Figure 2. The port numbering scheme and the terminology used herein are also given in Figure 2. Two port configurations are studied. For the *initial layout*, all ports are open as shown in Figure 3(a). For the *final layout*, ports 10, 11, and 12 are partially blocked as shown in Figure 3(b).

Three series of experiments were conducted. Series I, 29 Jan 1991, and Series II, 24 May 1991, are with the initial unbaffled arrangement. Series III, 12 Dec 1991, are with ports 10, 11, and 12 partially closed (baffled) as shown previously in Figure 3(b).

- b. Any modification to the downstream ports, such as baffles, that concurrently reduces downstream port flows and enhances upstream port flows. Baffles located downstream of ports 10, 11, and 12 have been evaluated in the model and found to be highly effective and probably provide both upstream enhancement and downstream reduction. Baffles located within these ports are helpful in that downstream port flows are reduced. However, since no mechanism to decrease the velocity in the approach channel is provided, these within port baffles require the overall approach-channel flow pattern to change; i.e., the reverse flow region will probably be enlarged and shift farther upstream. The change in flow pattern between Series I and Series II (Figures 20 and 21, respectively) occurs concurrently with a change in distribution of port flow as shown in Figure 13.

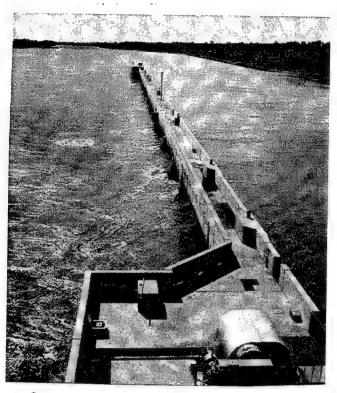
Small (estimated as 2 to 3 ft in diameter) but intense vortices occur intermittently in the navigation channel over port number 12.5 and, to a lesser extent, over port 12. Severe surface turbulence existed on the spillway side over ports 12.5 to 10. Smoother flow existed on either side upstream from these ports.

The upper pool dropped about 0.5 ft during the following ten hours. One (estimated as 3 to 4 ft in diameter) intense vortex occurred persistently over port number 12.5 and intermittently over port 12. Severe surface turbulence existed on the spillway side over ports 12.5 to 10. Smoother flow existed on either side of the guard wall upstream from port 10.

Guard wall, 24 May 1991. View looking upstream; the turbulence along the spillway side is most severe for ports 10-12.5

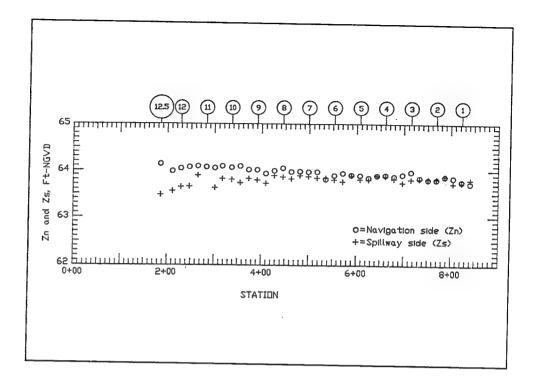
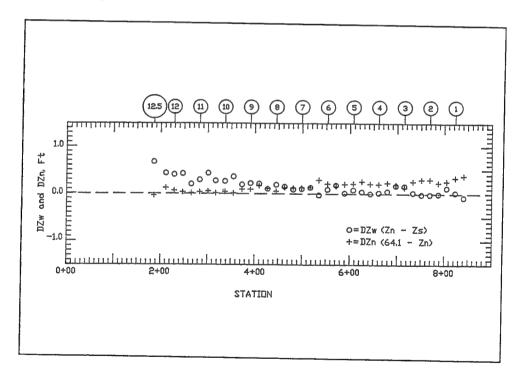
Figure 8. Water-surface measurements (29 Jan 1991), Upper pool el. = 64.0 ft NGVD, River flow = 85,000 cfs

- a. Tow drift. The upstream drift of tows from the lock chamber results from a water surface that slopes downwards from the lock chamber into the approach area. The slope continues over the total length of wall, Figures 8-10, and is most severe between station 1+75 and about station 4+00. A tow will drift in an upstream direction until drag due to increasing near-surface velocities, Figures 18 and 19, and mechanical friction between the barges and the wall cause the motion to cease.

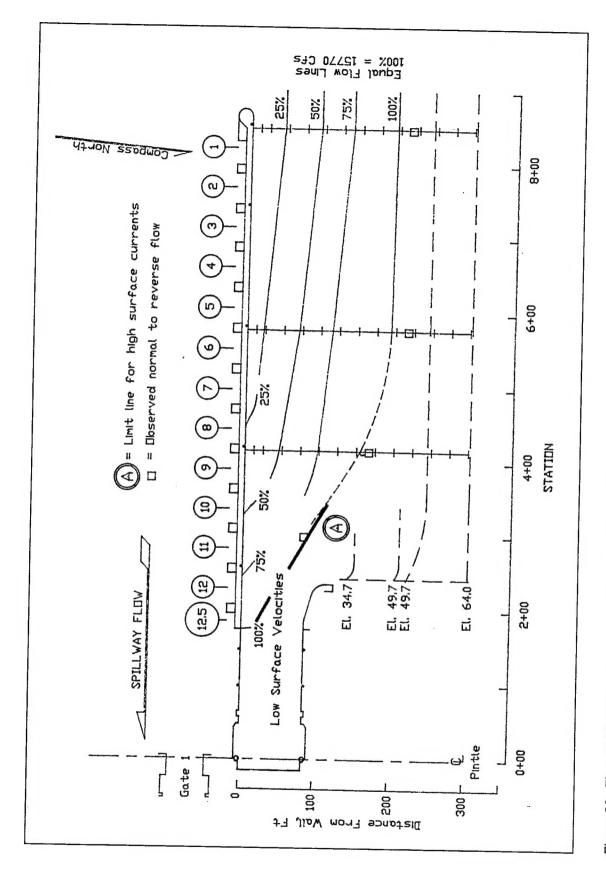
Figure 20. Flow distribution in the approach channel. 29 Jan 1991 experiments (Q = 85,000 cfs)

- b. Tow binding along the guard wall. The slope of the water surface over the approach area is indicated by the flow lines shown in Figures 20 and 21. The highest water-surface elevations are within the low velocity region landward of the 100% flow line. The lowest elevations are within the high-velocity region near the guard wall. The gravity force resulting from this slope, and the drag force resulting from velocity, have components that are directed toward the wall. For a 600-ft long tow, these forces are expected to be greatest when the tow is positioned between stations 1+75 and 7+75 based on the flow lines shown in Figures 20 and 21. The position for greatest normal force is independent of direction of tow movement. However, the velocity and slope parallel to the wall, which affect the power needed to offset friction between the tow and the wall, will affect the location at which binding occurs.

- c. Upbound tows. The upbound tow, to avoid binding along the guard wall, probably should be oriented with the bow off the wall and aligned with the approach flow. The operation needs to be carried out without having the stern impact on the miter gate. For lower flows with modest forces, Figure 20 for example, the operation is probably not an unusual

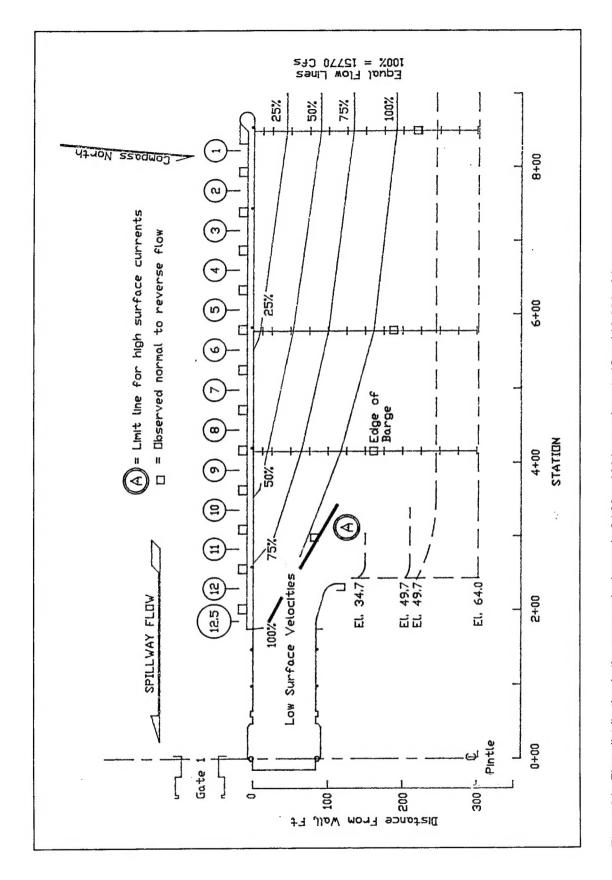
Figure 21. Flow distribution in the approach channel. 24 May 1991 experiments (Q = 116,000 cfs)

- exit condition. For higher flows with severe forces, Figure 21 for example, the operation is more unusual in that an inadequate operation apparently results in binding whereas an excessive operation forces the tow into the left (descending) bank. More precise suggestions for operation require field assessments so that towboat power and steering mechanisms can be considered.

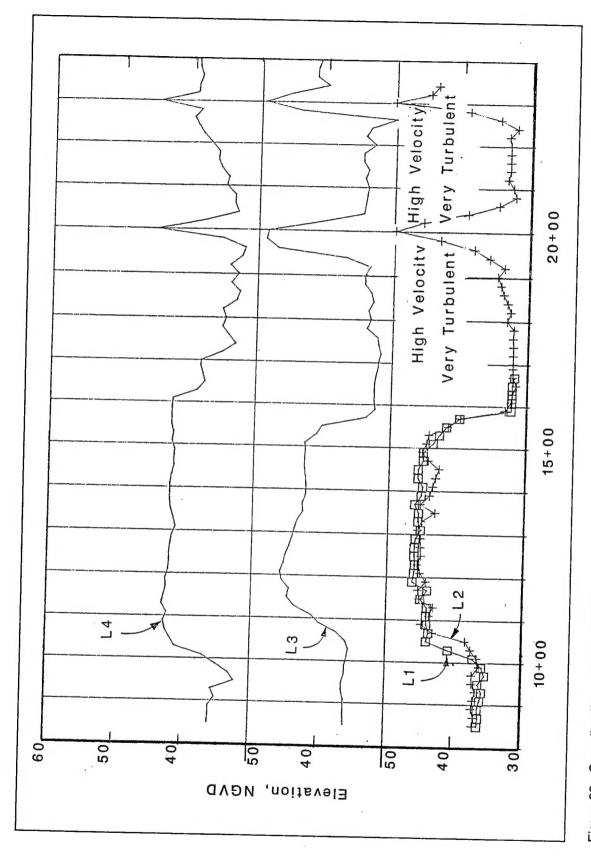
Figure 22. Sounding lines (24 May 1991)

Four sounding lines were obtained upstream from the guard wall during Series II, 24 May 1991. The primary interest items are the clearance, the extent of sedimentation, and high surface currents associated with a berm, station 10+00 - station 16+00, and two dikes, stations 20+00 and 23+00, extending from the left bank into the Red River navigation channel. The bottom elevations, relative to a water surface at El. 64.9, are shown in Figure 22.

High surface currents apparently occur immediately downstream of each of the two dikes as suggested by the profiles of the dikes shown in Figure 22, lines L3 and L4, as well as by on-site visual observations. Severe turbulence is suggested by interference on the sounding record, commonly associated with air entraining flow, as well as by on-site visual observations.
